Vegreville Flood Risk Mapping Study

Canada-Alberta Flood Damage Reduction Program

April 1994

SNC • LAVALIN

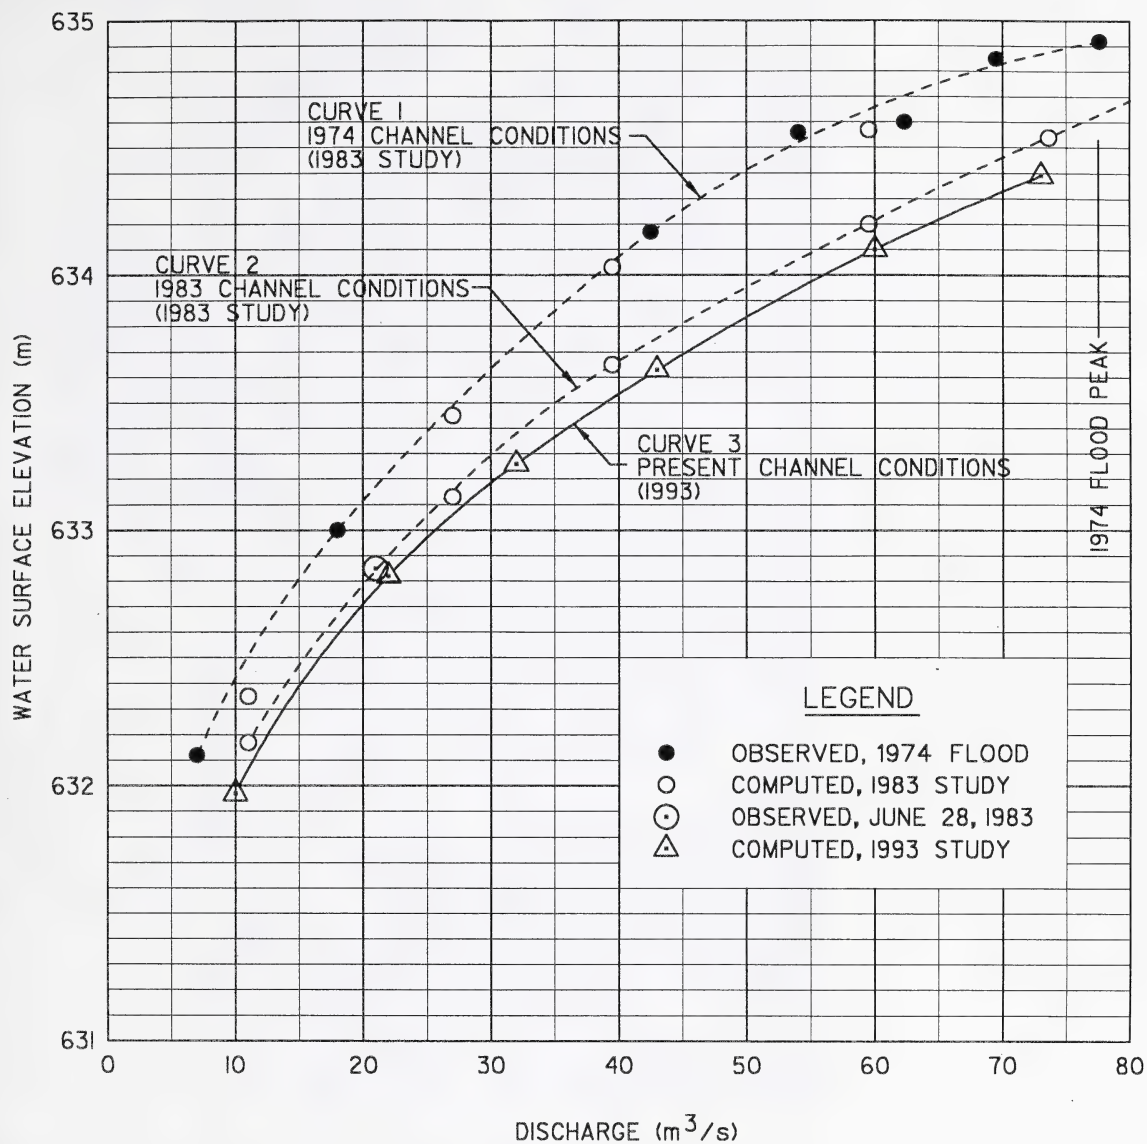
FIGURE 3.6

VERMILION RIVER AT HIGHWAY 16 - RATING CURVE

The 1983 study also tested the variation of n with stage, using observed water levels for various discharges at the Highway 16 bridge. It was found that calculated water levels were close to the observed levels, for a single value of n (see Curve 1, Figure 3.6). It was therefore concluded that Manning's n did not vary significantly with stage; that conclusion has been retained for the present study.

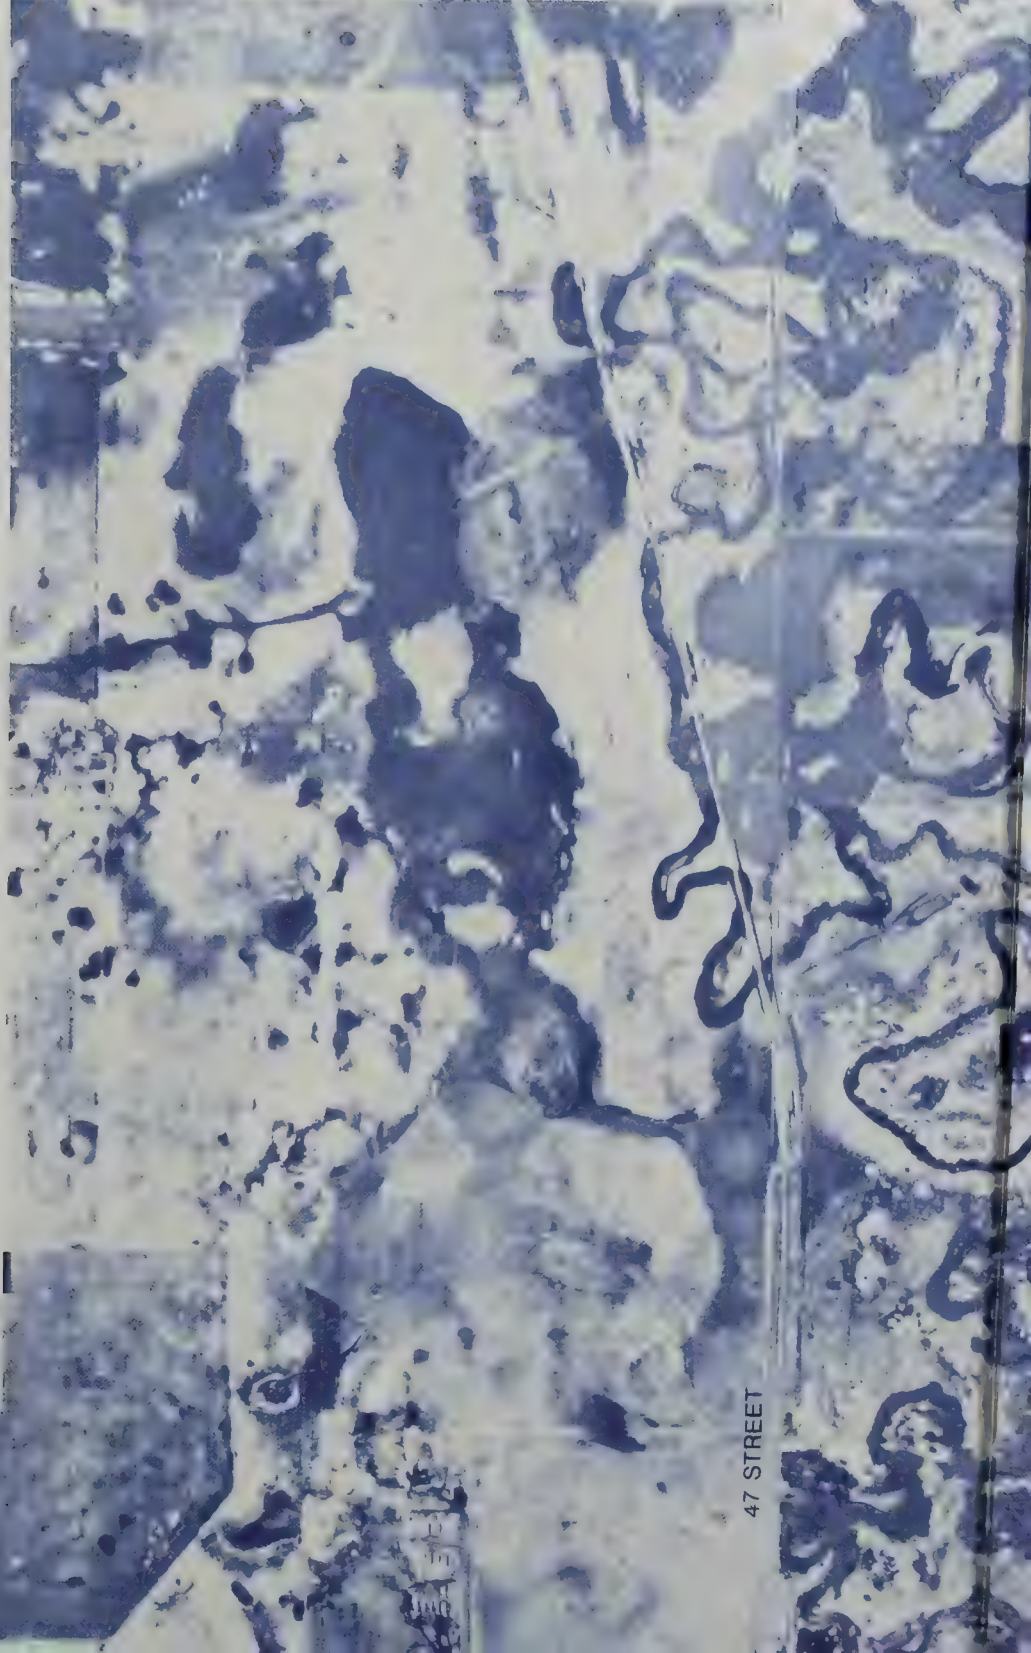
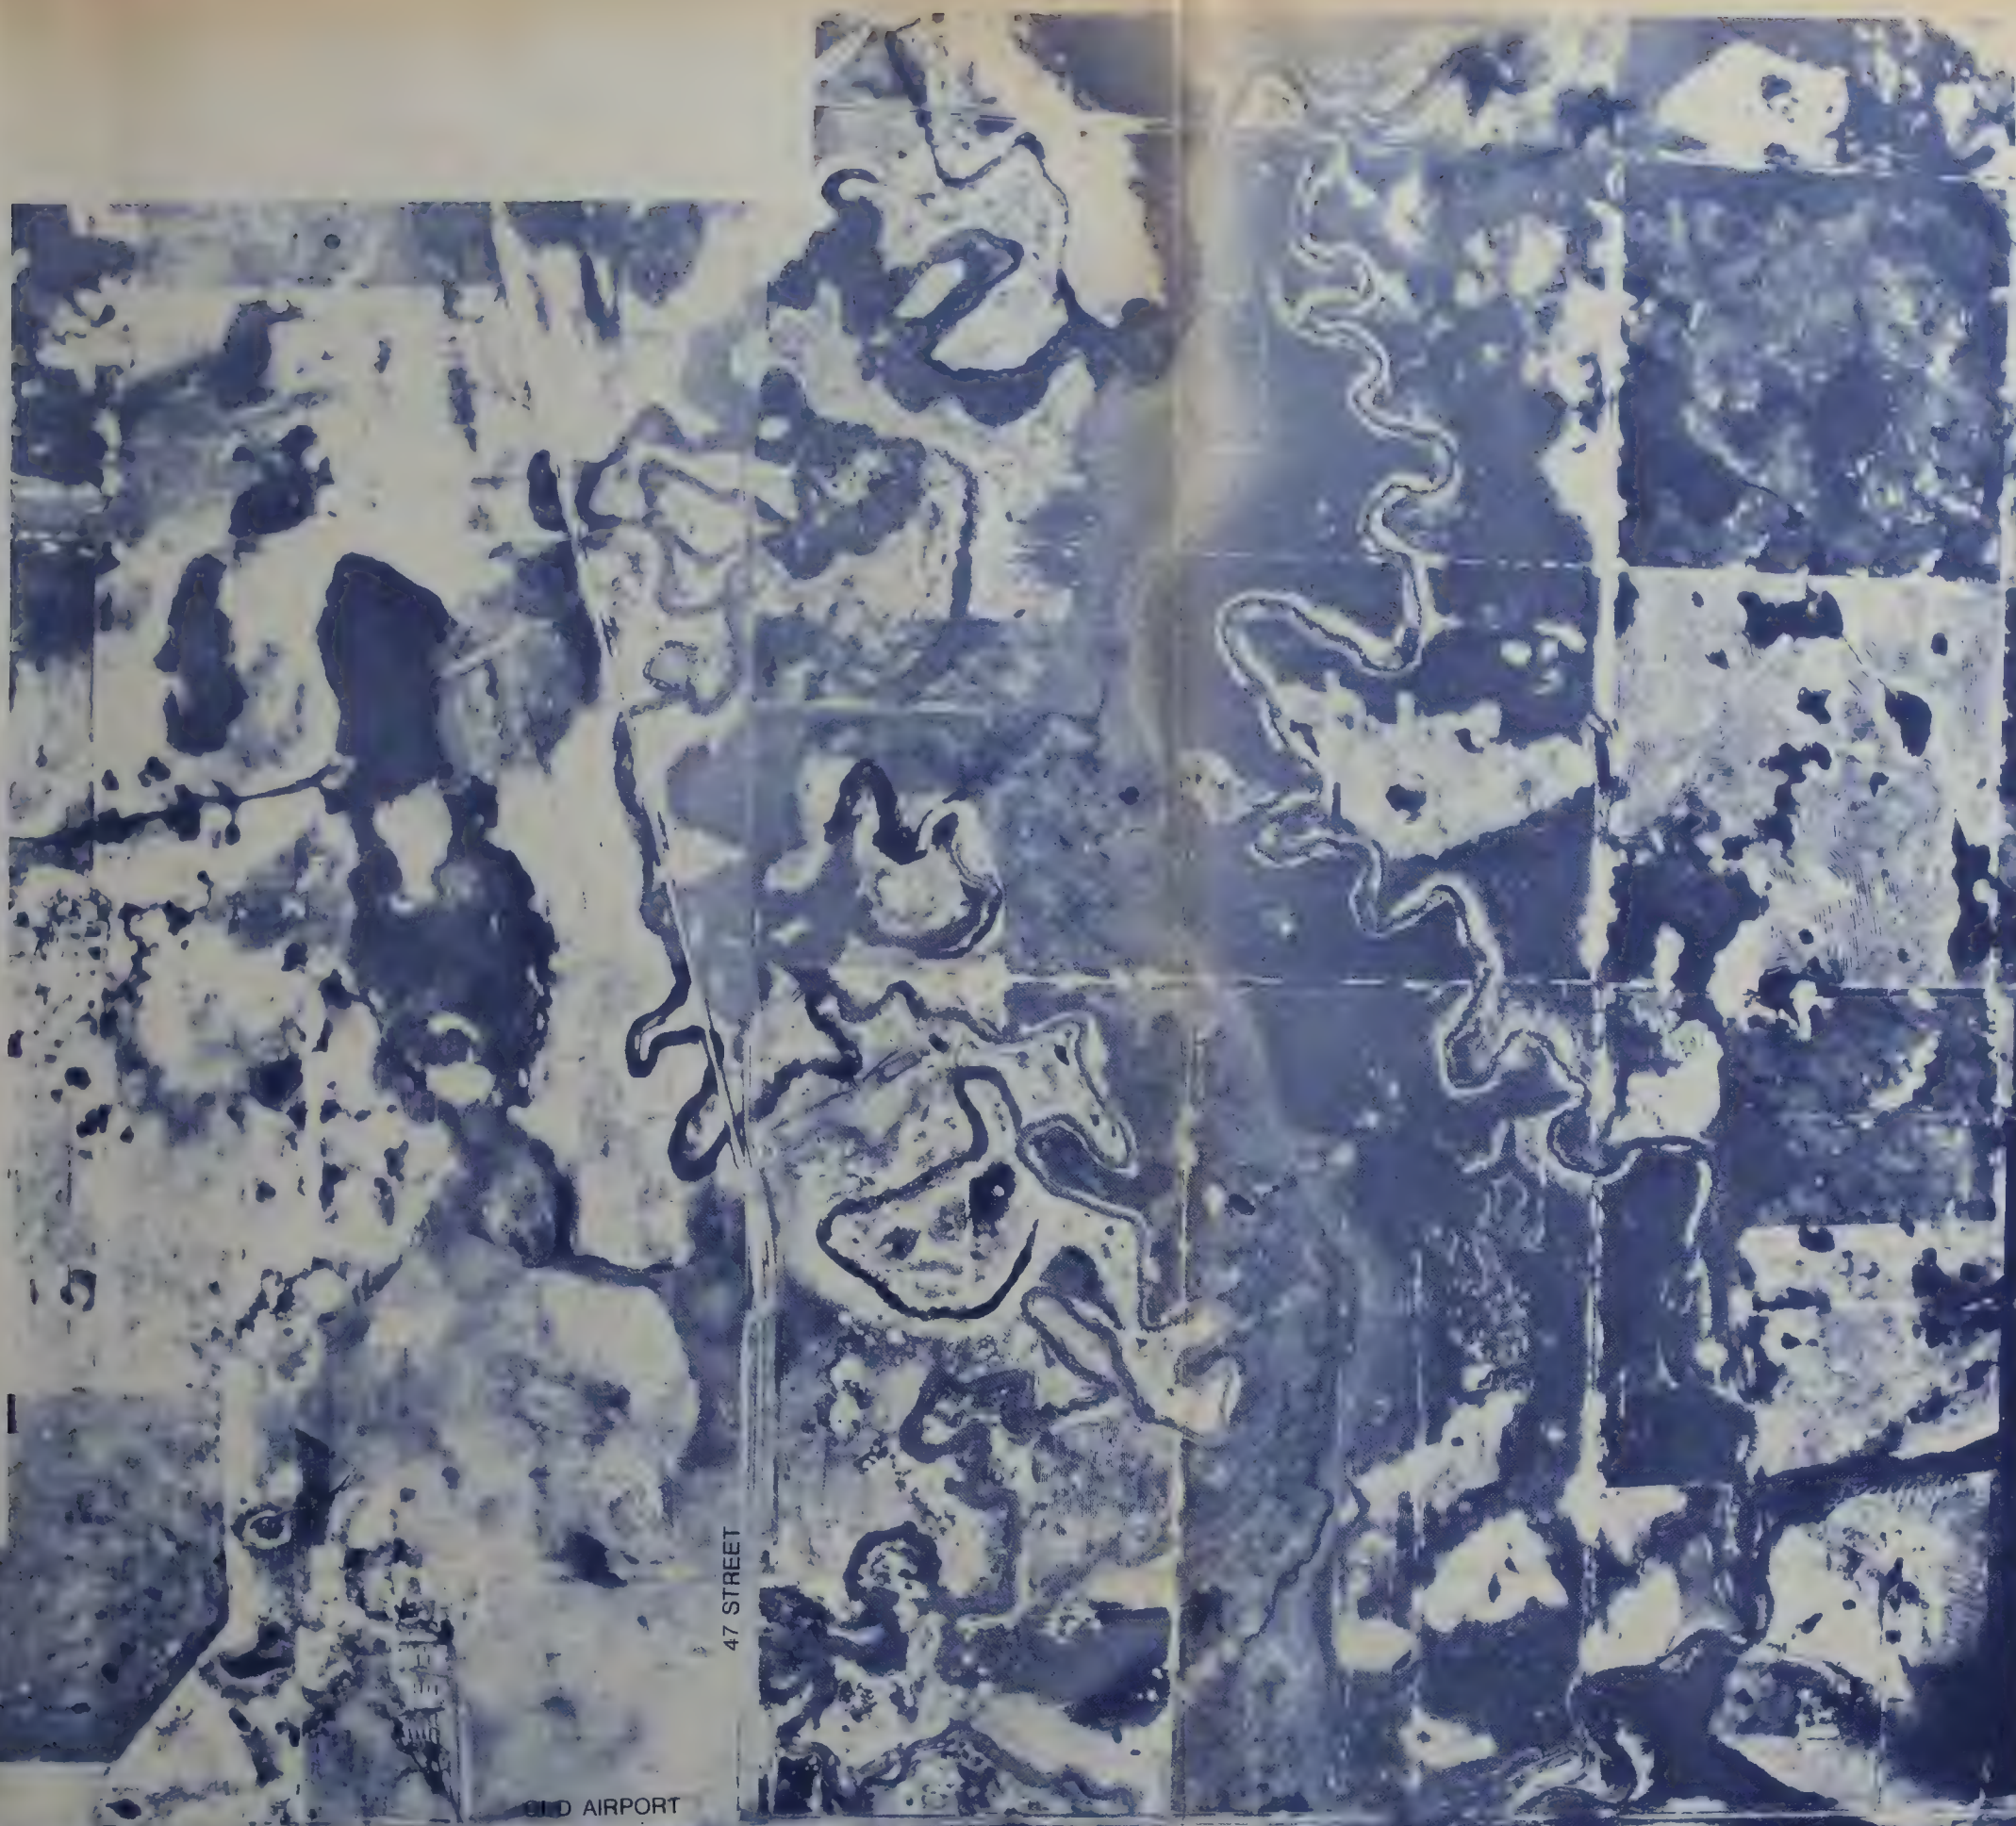
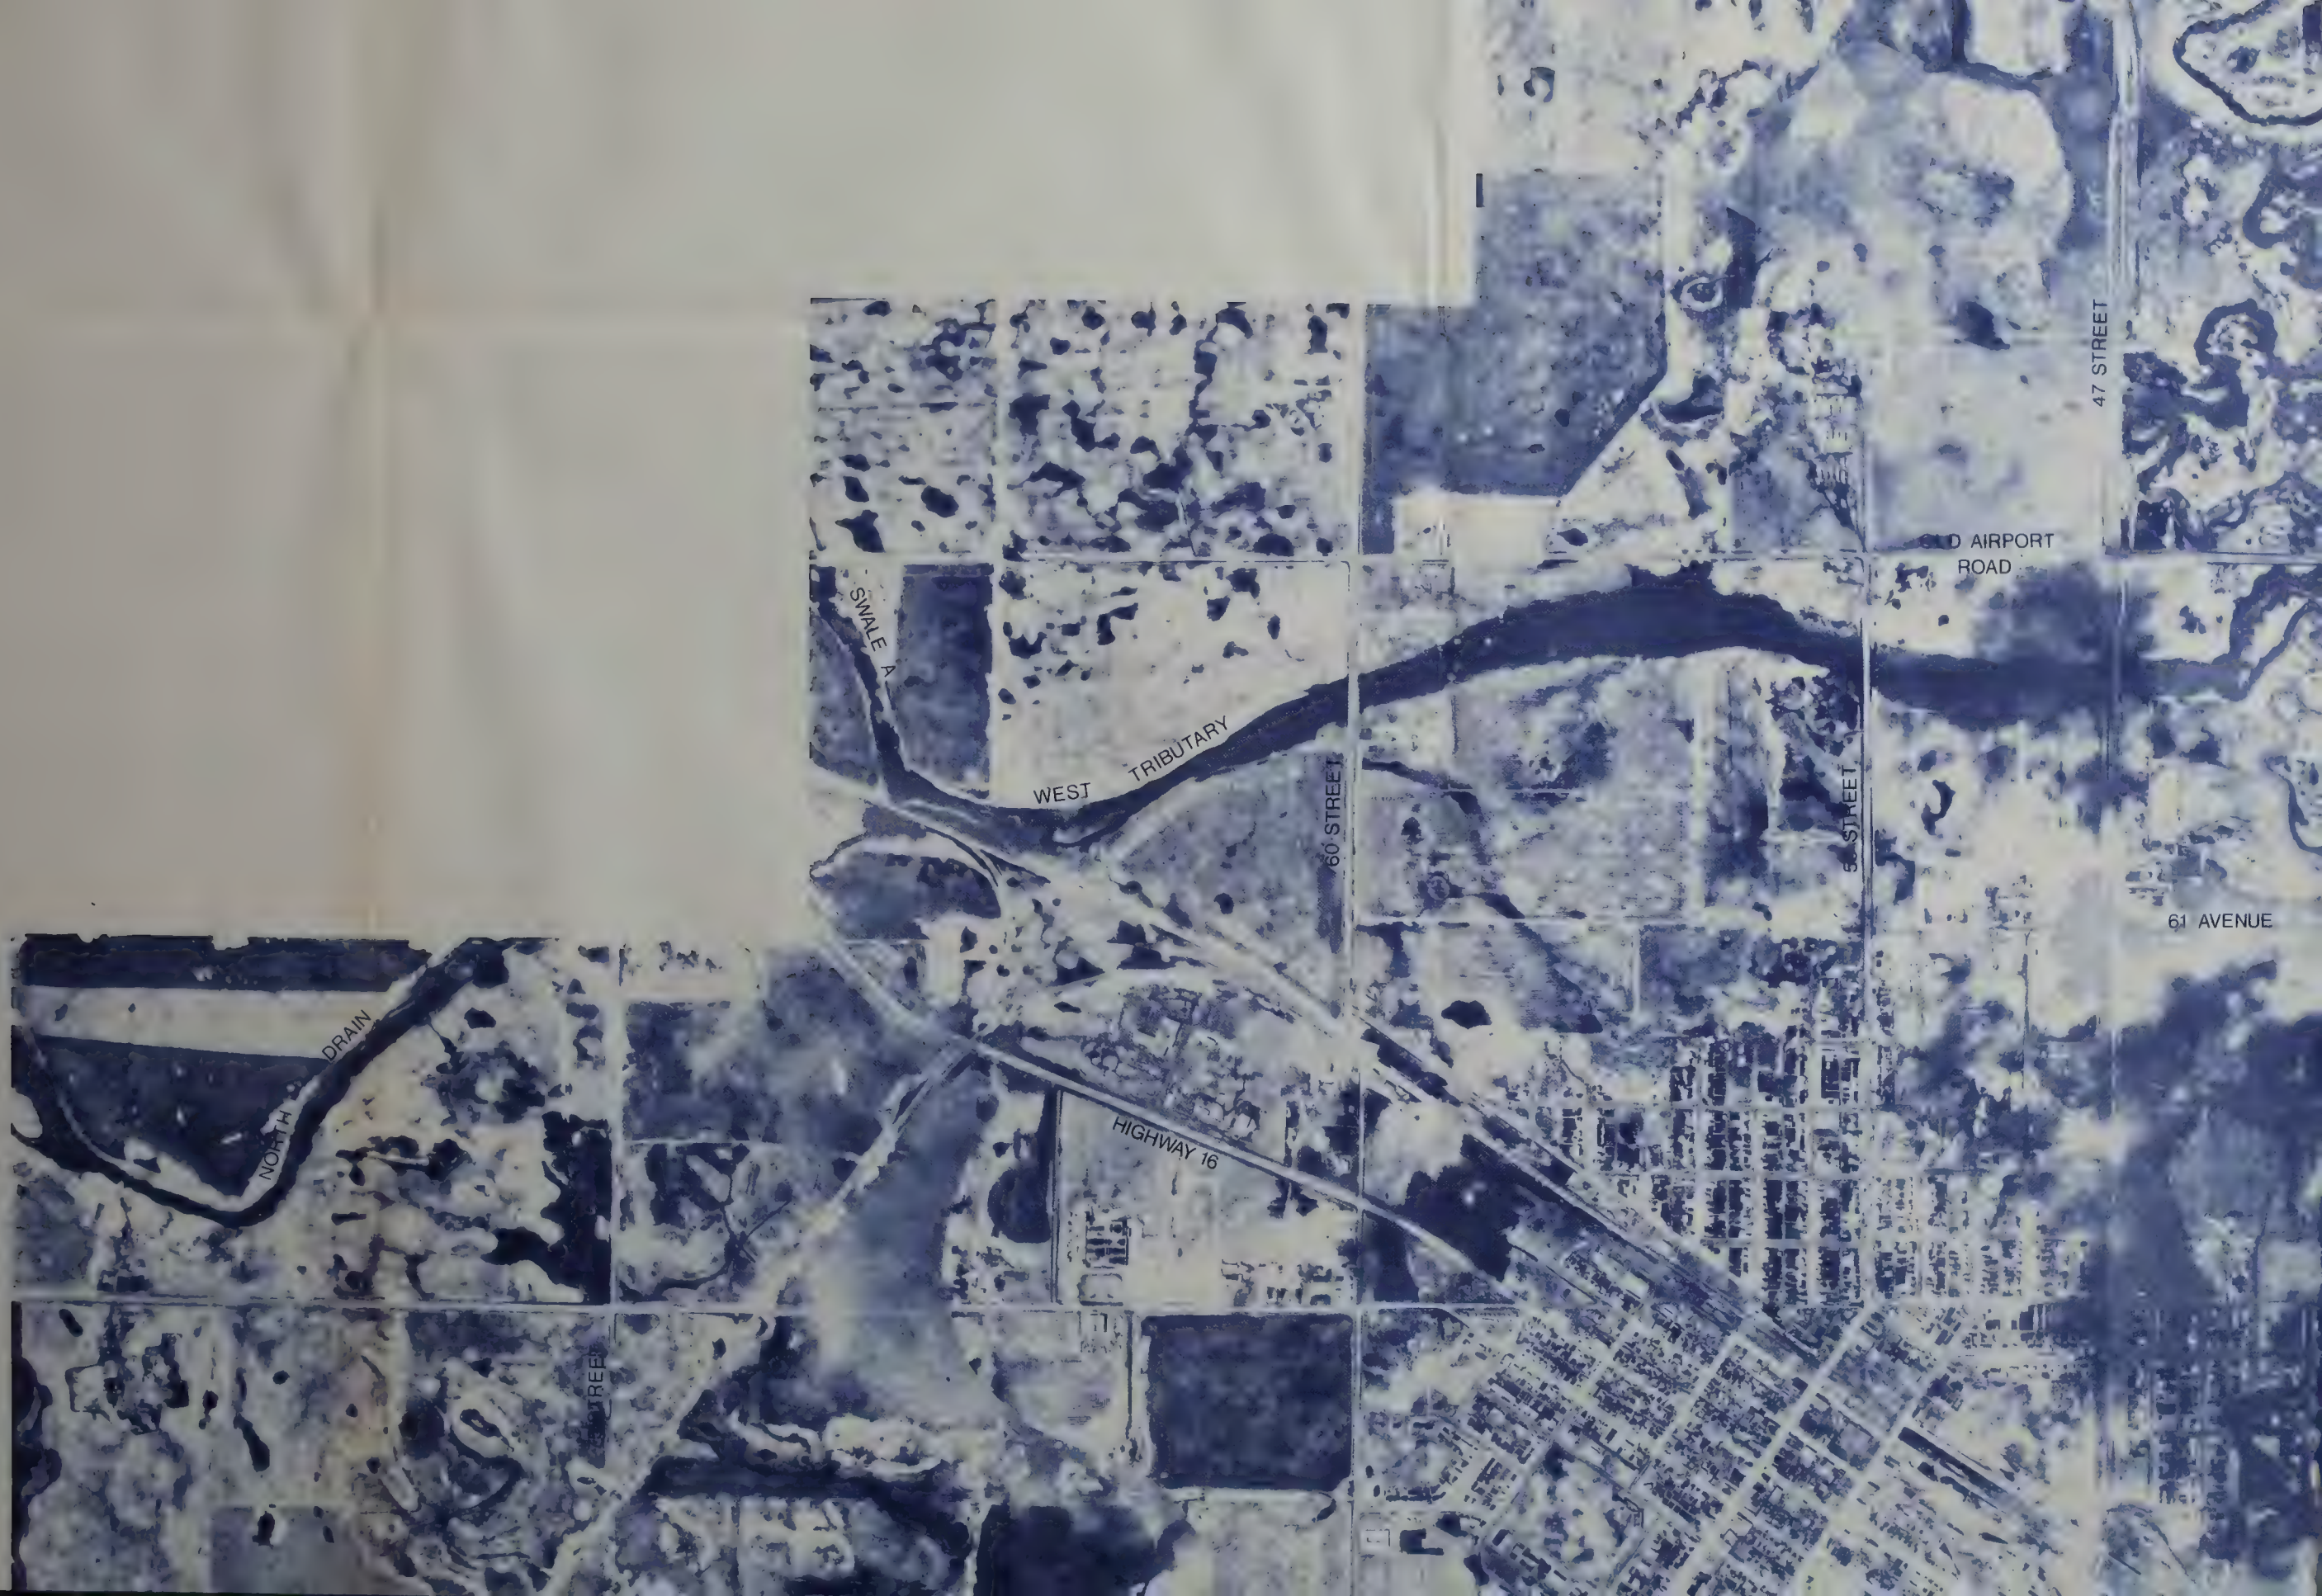
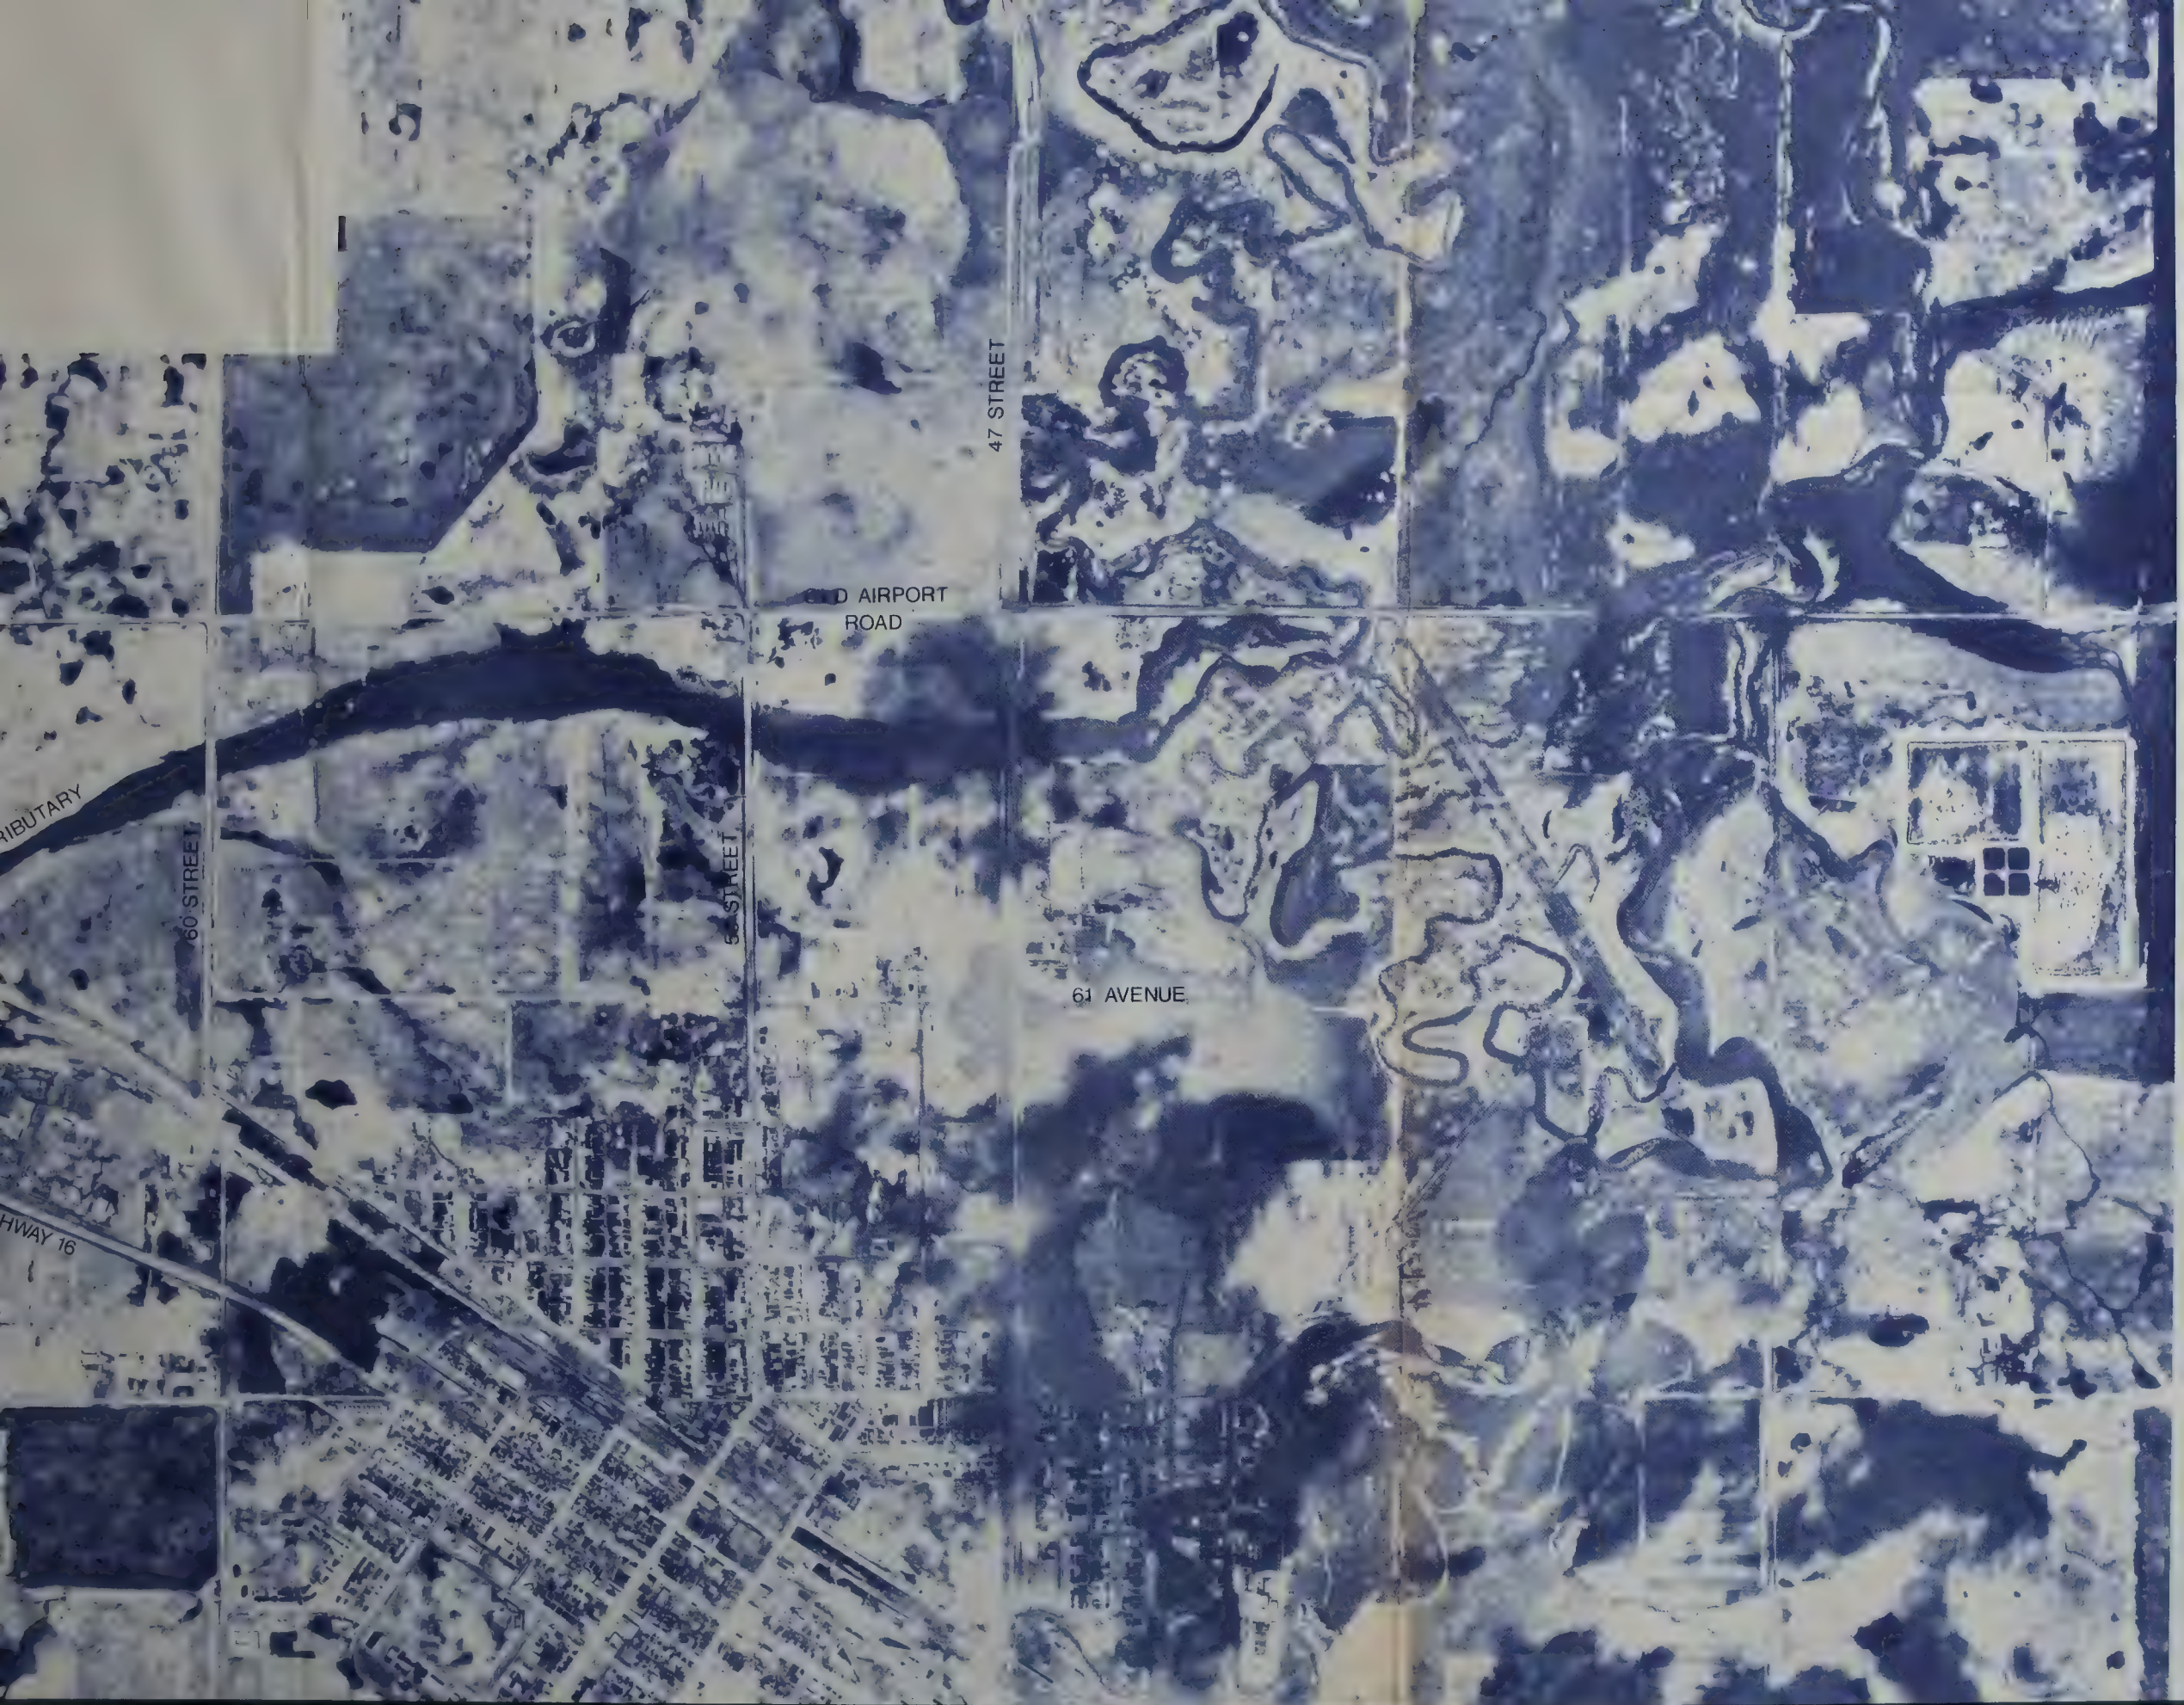
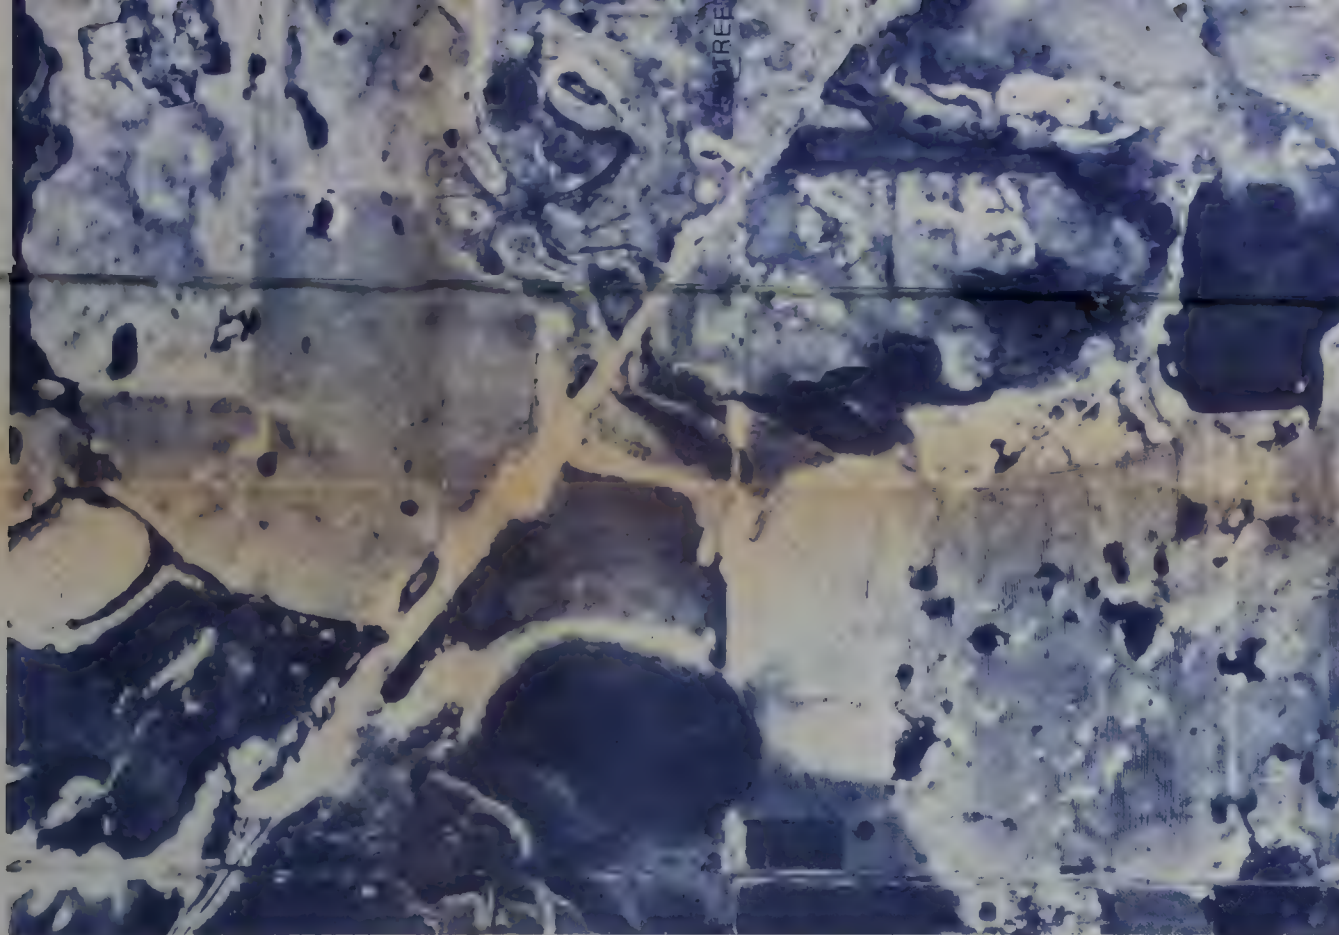
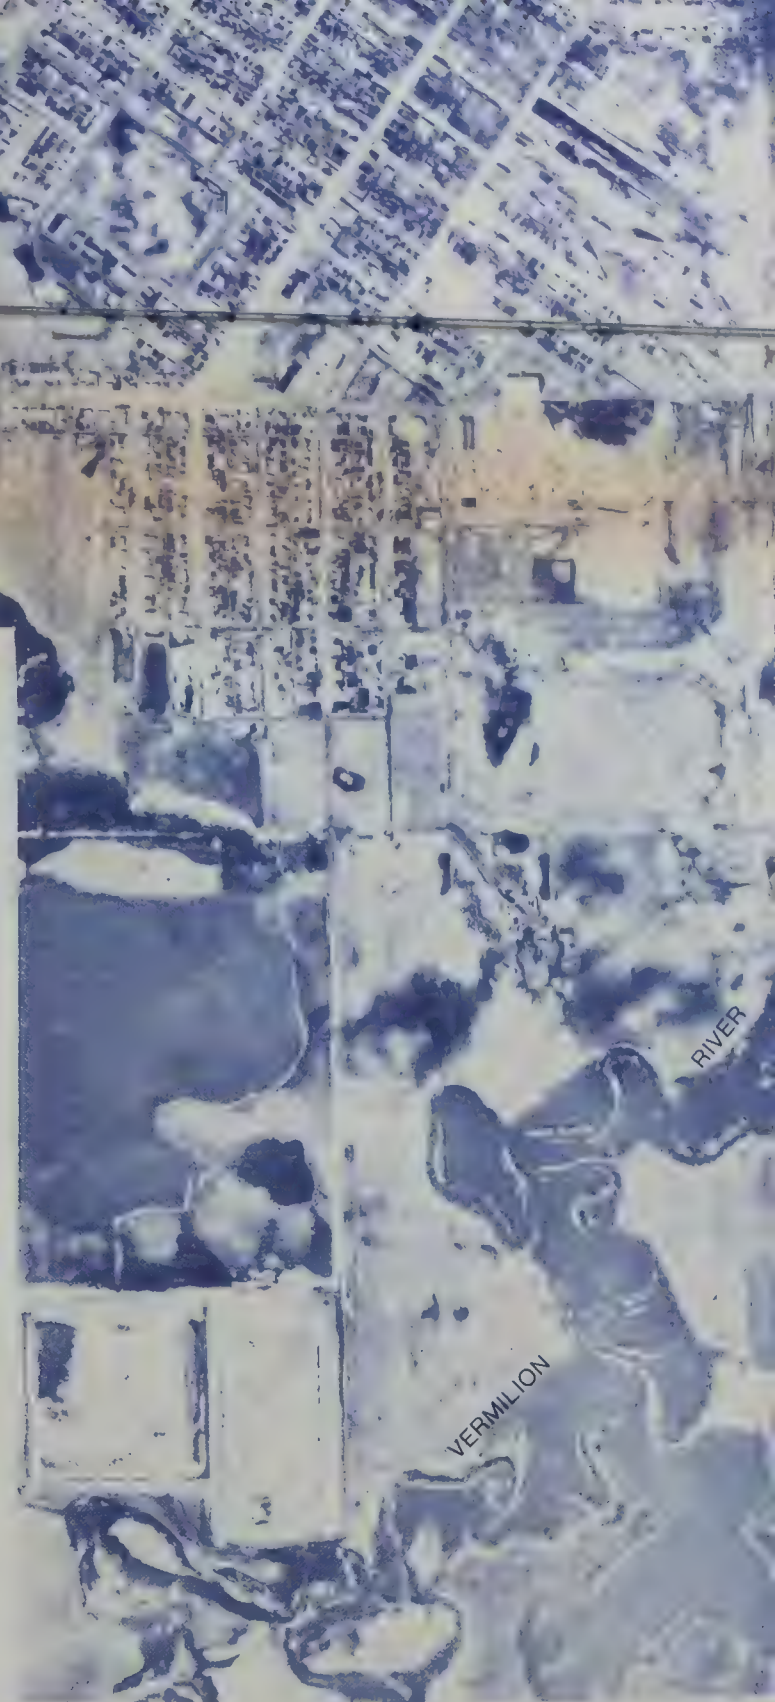
GREVILLE FLOOD RISK MAPPING STUDY
FIGURE 3.7
1974 FLOOD PHOTO MOSAIC

PHOTO DATE: APRIL 22, 1974

ROLL: AS 1283

SCALE: 1:12,000
